Exploring Midwest City: Adventures in Stormwater Master Planning

OFMA Annual Conference

9/23/2025

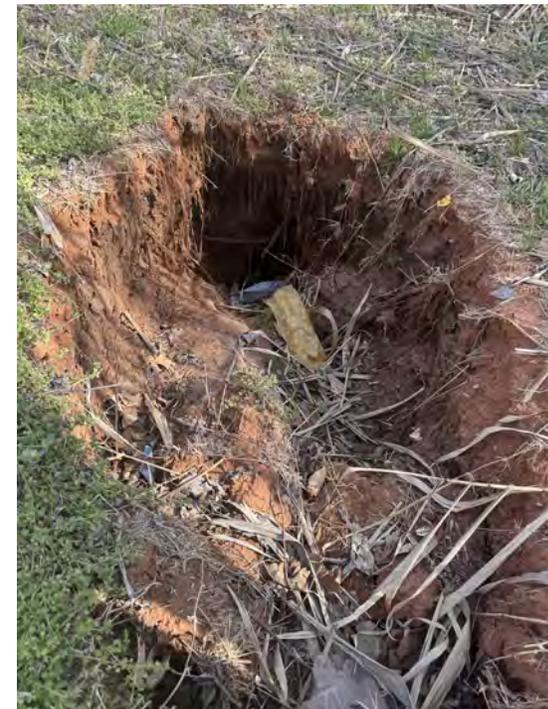
Broken storm drain in Midwest City neighborhood causing sinkholes in backyards
