Jenks Riverwalk Bank Stabilization Evaluation

OFMA Conference

Muscogee Creek Nation
Jenks Riverwalk Geomorphic Assessment
 Location Map

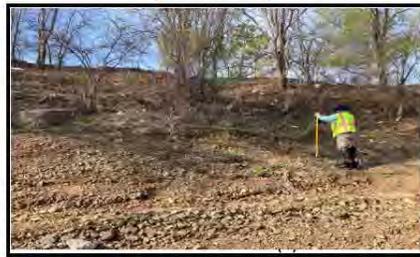
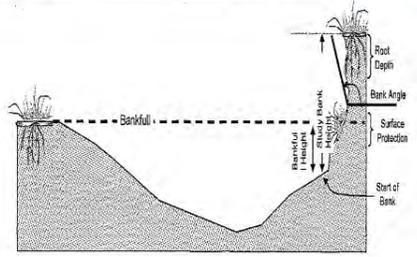
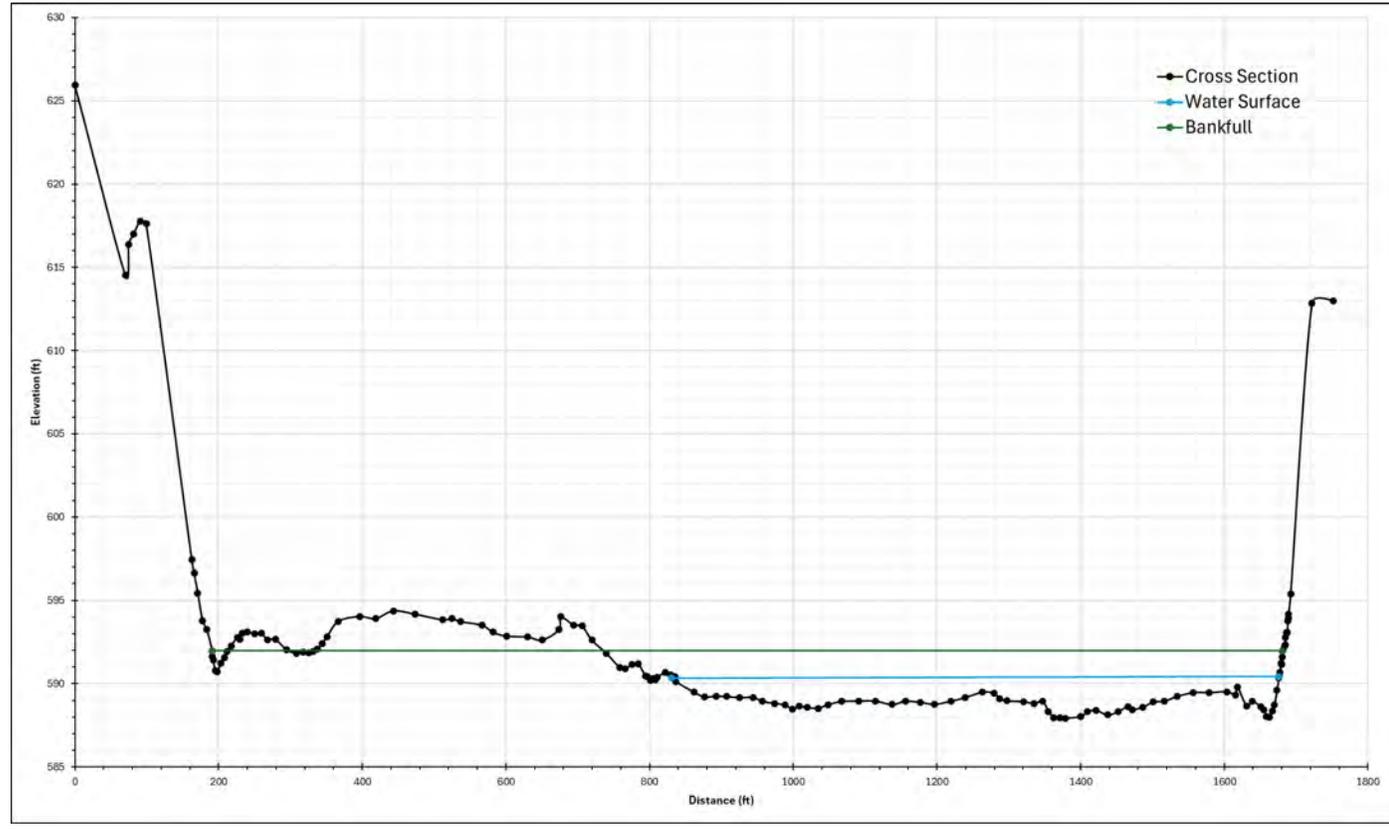
BEHI Variable Worksheet

Stream: Arkansas River Station/Cross Section: STA 25+00
 Stream Type: Valley Type: Reach: Date: 3/12/2024
 Observers: SCK, KWB Photos: IMG 7826

A Bank Ht 25		D Root Depth 12.5
	B Bankfull Ht 4		A Bank Ht 25
	C (A/B) 6.25		E (D/A) 0.5
	↓ 10		↓ 4
	F Root Density 40		H Slope 45
	G (F*E) 20		↓ 3
	↓ 7		
	I Surface Protection 40	Bank Material Adjustment	0.0
	↓ 5	Bedrock (Overall Very Low BEHI)	
		Boulders (Overall Low BEHI)	
		Cobble (-10 if uniform medium to large)	
		Gravel (+5-10 depending on % sand)	
		Sand (+10)	
		Silt/Clay (No adjustment: -20 if mostly clay)	
		Stratification Adjustment	0.0
		Add 5-10 points, depending on position of unstable layers in relation to bankfull stage

VERY LOW	LOW	MODERATE	HIGH	VERY HIGH	EXTREME	ADJECTIVE RATING
5 - 9.5	10 - 19.5	20 - 29.5	30 - 39.5	40 - 45	46 - 50	Moderate
						and
						TOTAL SCORE
						29.4

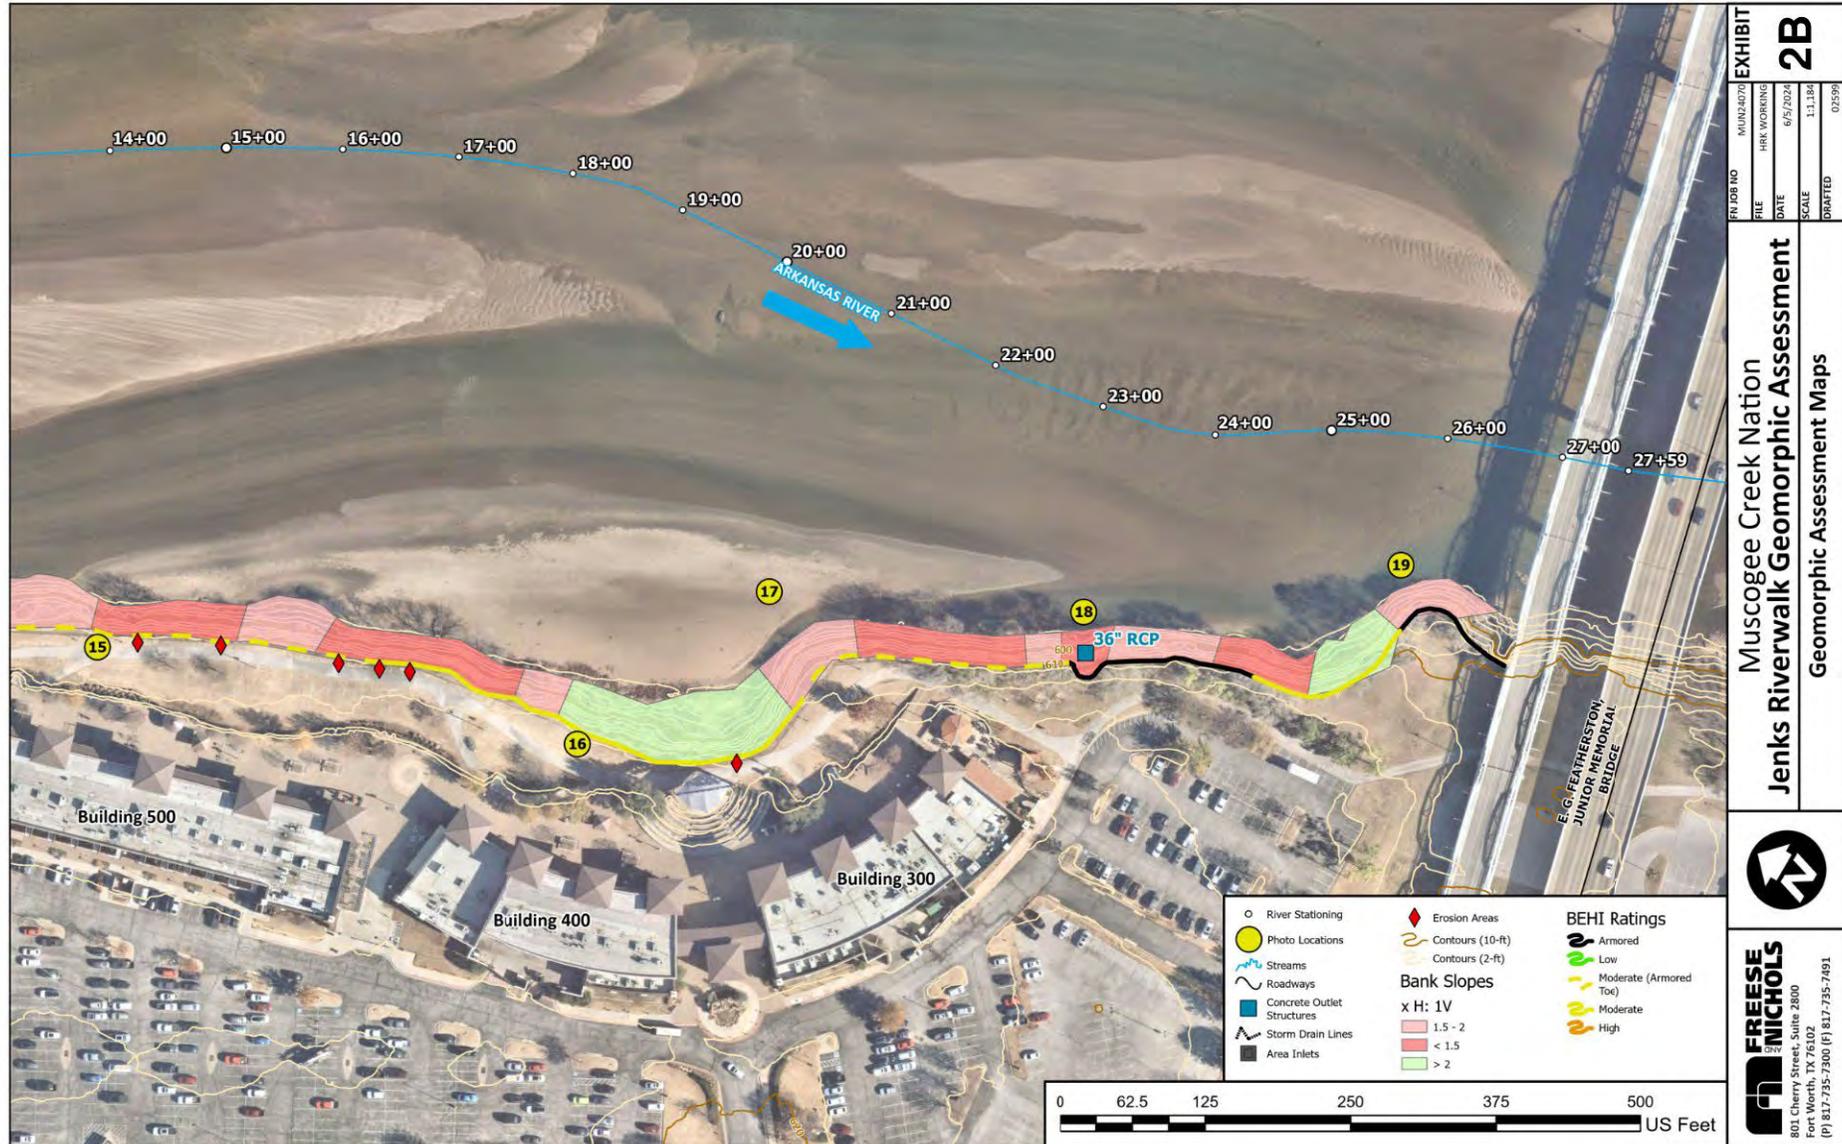
PROJECT NO.	MUN48470	EXHIBIT
FILE	HRK WORKING	2B
DATE	6/5/2024	
SCALE	1:1,184	DRAFTED
		03/2024

Muscogee Creek Nation
Jenks Riverwalk Geomorphic Assessment
 Geomorphic Assessment Maps

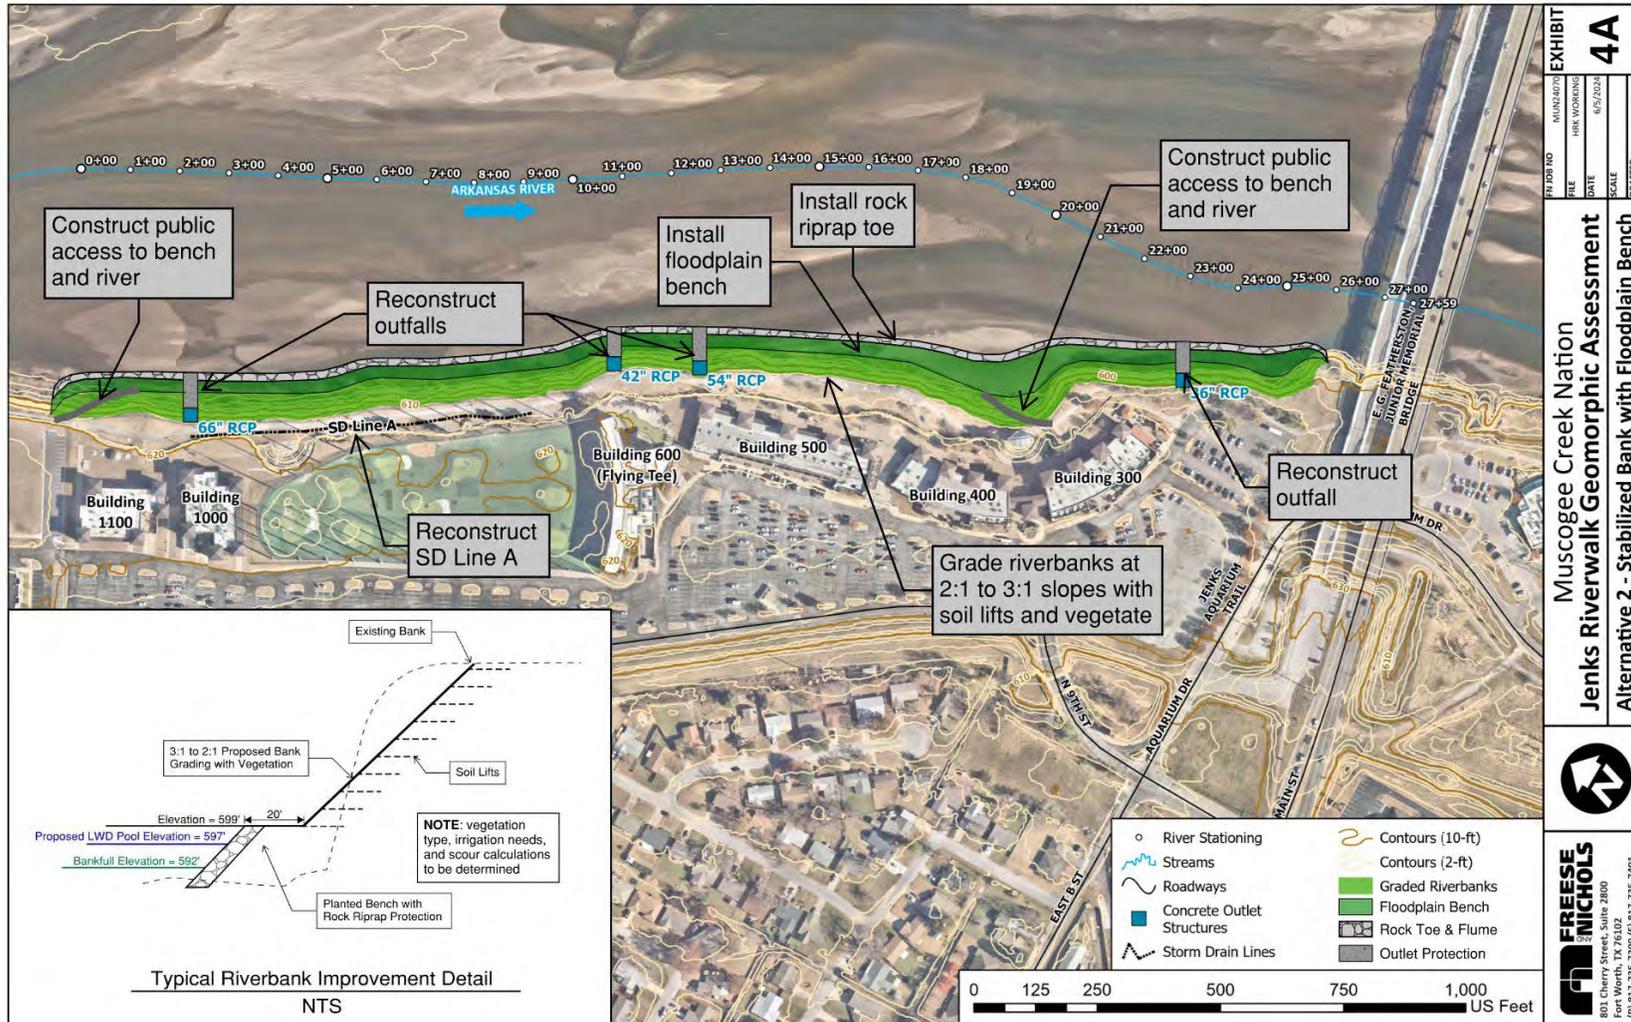
Alternative 2 – Stabilized Bank with Floodplain Bench

Muscogee Creek Nation
Jenks Riverwalk Geomorphic Assessment
 Alternative 2 - Stabilized Bank with Floodplain Bench
