Assessing Culvert Conditions Based on Photogrammetry Data Captured Using Drone Technology

Kaleb Rigdon

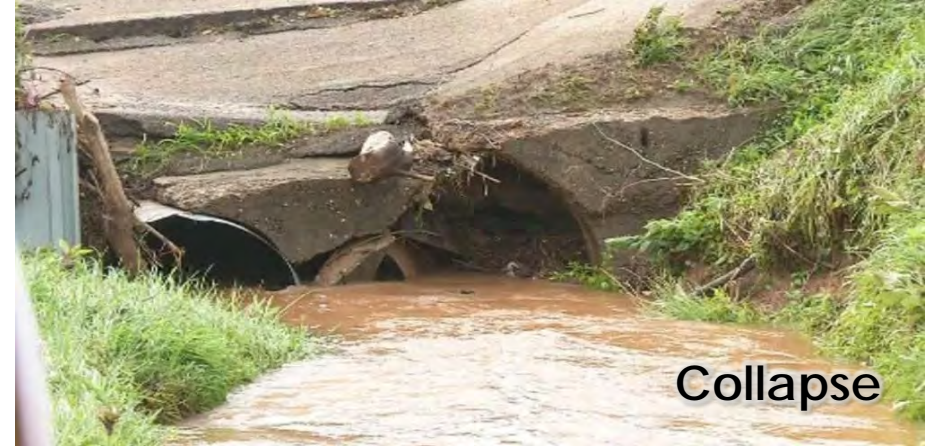
Collapse

Due to aging infrastructure and increased flooding culverts are negatively impacted.

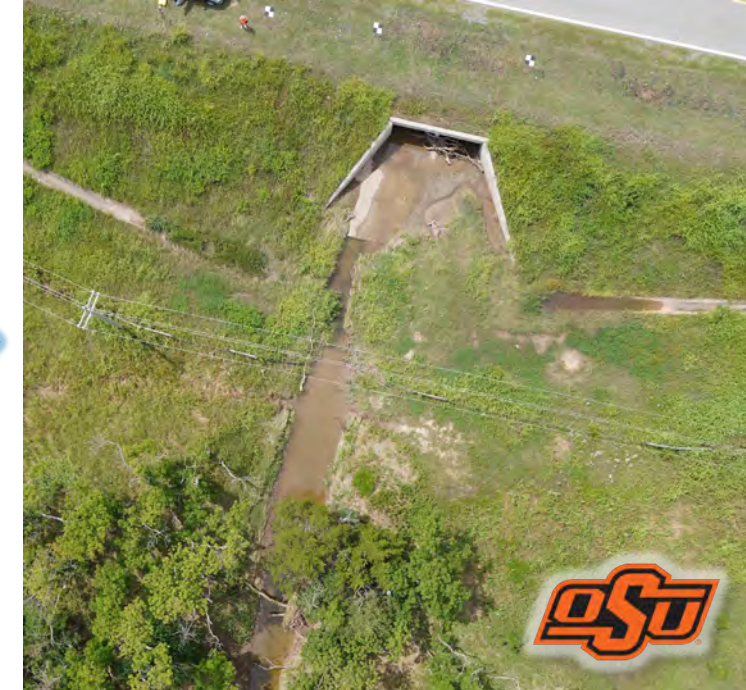
Drone Survey

- Current method being used.

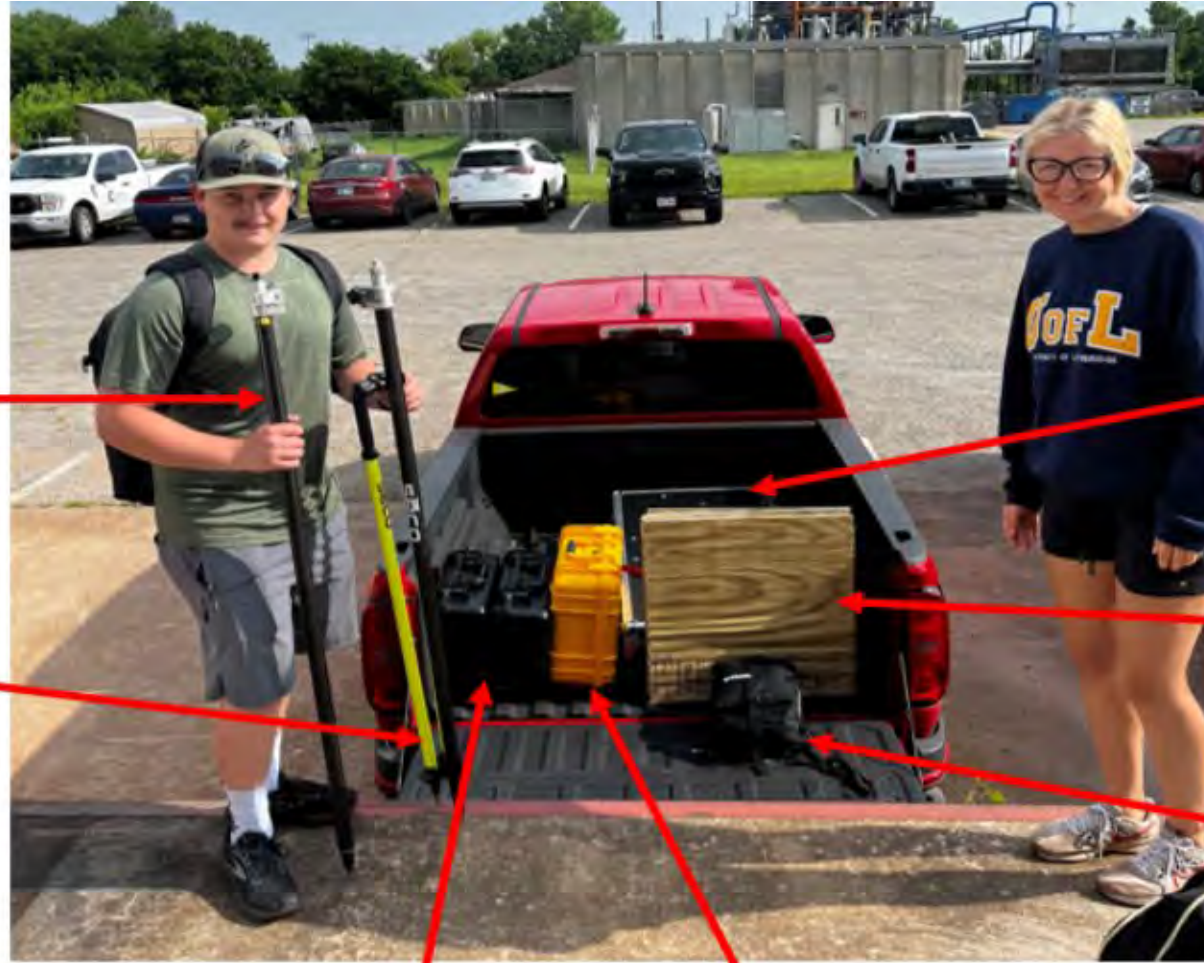
UAV Equipment

Tri Pod for Rover
(for use with tilt)

Tri Pod for Rover
(regular use)

Wingtra batteries,
chargers, tablet and
antenna.

Trimble R980
GNSS Rover

Wingtra

Control Point
Checker Boards
x4.

Trimble R980 GNSS
Rover tablet and
accessories

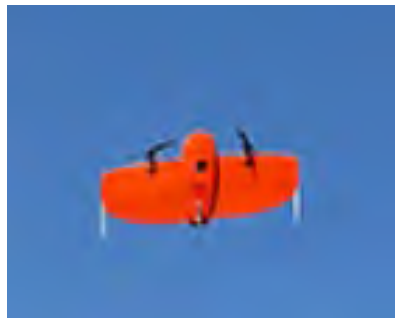
Flight Plan

- Maximum UAV ceiling is 400ft.
- Flight height is 200ft.
- Fixed wing drone, transition height 170ft.
- Flight direction is perpendicular to road.

A screenshot of a flight planning application interface. The top status bar shows the time as 10:37 on Wednesday, July 2nd, with a battery level of 94%. The main menu includes 'Settings', 'Flight plans', 'billi...s_564', and 'Help'. The central map displays a flight plan with a grid of vertical lines and a red circle indicating a take-off point. A tooltip for this point shows 'A H 0 ft (978 ft AMSL)'. On the right, a sidebar for the flight plan 'billings_564' shows it is 100% complete and contains one flight. Below this, there are sections for 'Safety parameters', 'Geobarrier', and 'Take-off' parameters: Transition height (170 ft) and Transition direction (153 deg). The 'Area' section shows: Terrain following enabled, Height above Ground (200 ft), Ground sampling distance (0.4 in/px), Flight direction (182 deg), Side overlap (70%), and Front overlap (70%). The bottom status bar indicates 'Total work done: 3.20 mi, 6 min 9 s, 15.19 ac, 135 photos, Default'.

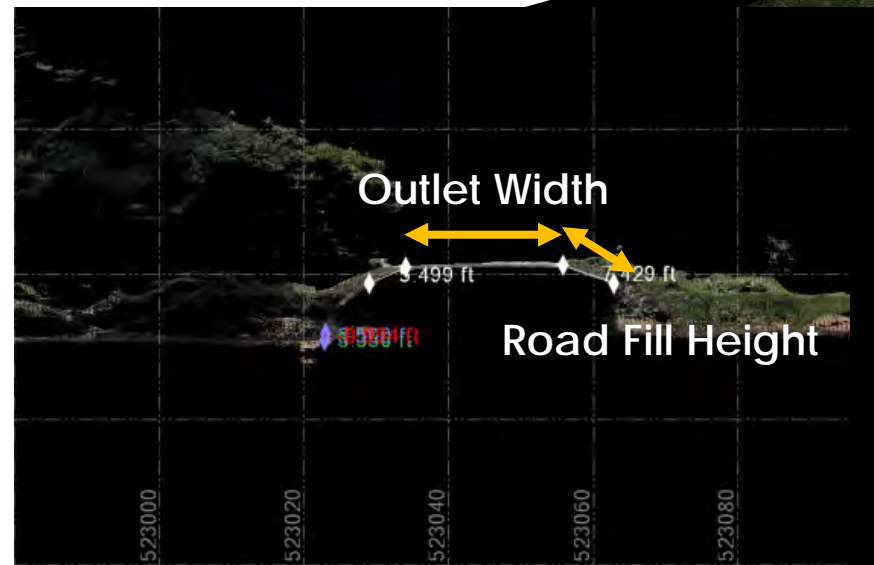
Culvert Characteristics

- Using 3D imaging to assess the culverts.
- Categorical data and external measures are easy to derive.
- Limited internal measurements of culvert.

Culvert ID	Road Fill Height (ft)		Structure Length (ft)		Outlet Height (ft)	
	Ground	UAV	Ground	UAV	Ground	UAV
621	2.2	2.2	33.2	32.3	6.5	10.4
564	1.9	2.1	81	81.6	6.7	8.8
1998	4.1	1.1	90	85.9	6	8.3

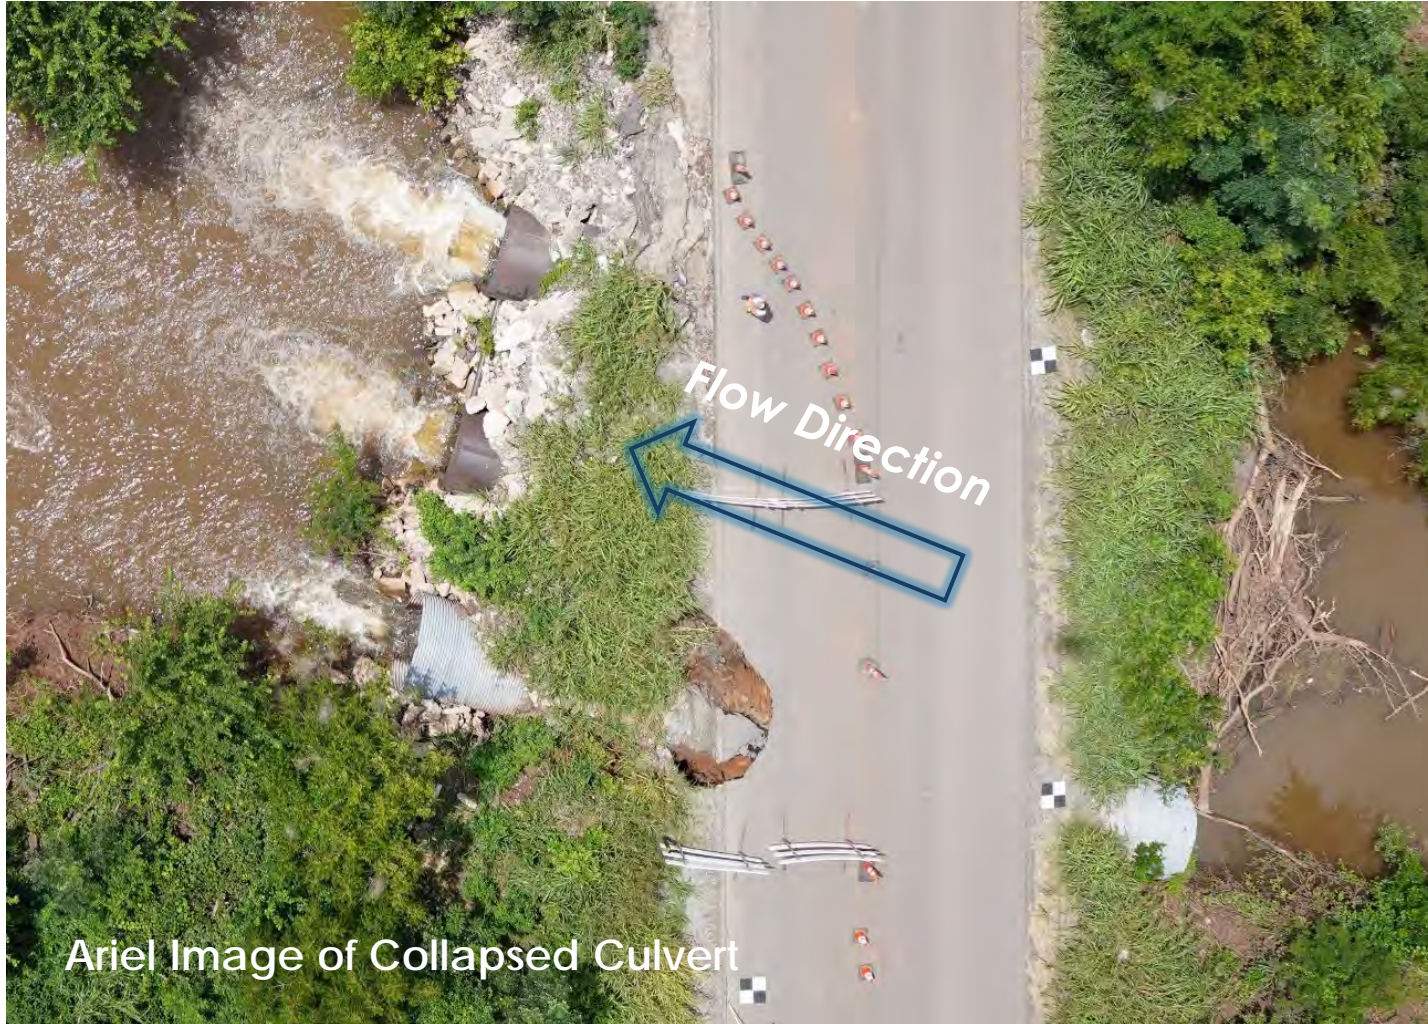
Ariel Image of Collapsed Culvert

- Debris blocking Inlet.
- Road collapsed, culvert intact.
- New use for the technology.
